Bilddokumentation Befahrung

89567 Sontheim Grabenstraße
Von :10149 Nach :10150 Flr. :in

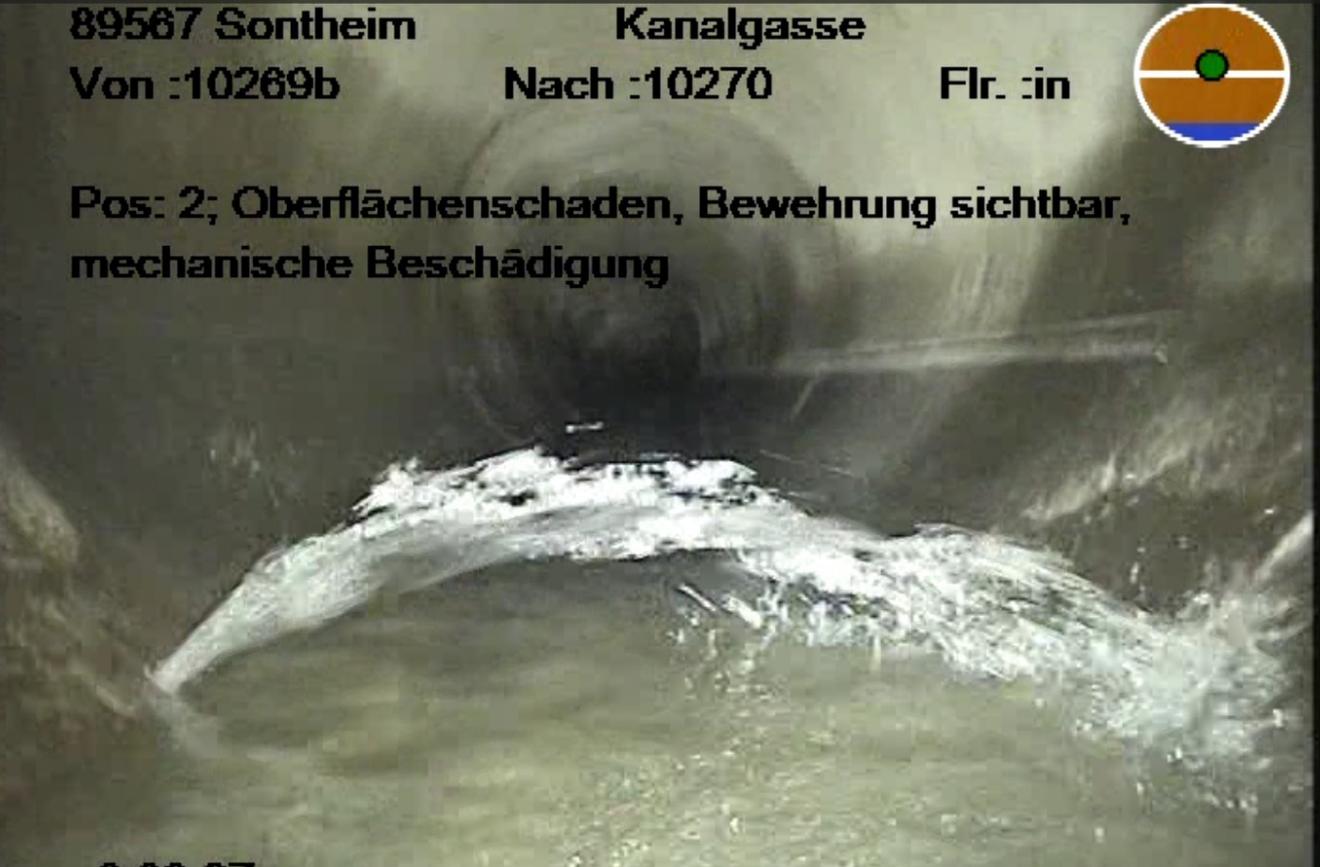
89567 Sontheim Kanalgasse
Von :10269b Nach :10270 Flr. :in

Pos: 2; Oberflächenschaden, Bewehrung sichtbar, mechanische Beschädigung
